Repair of mould damage by sealing off mould-infested areas – particle impermeability of structural layers

Short title: Repair of mould damage by sealing off

Conducted by: AIBau – Aachener Institut für Bauschadensforschung und angewandte Bauphysik, gGmbH, Aachen

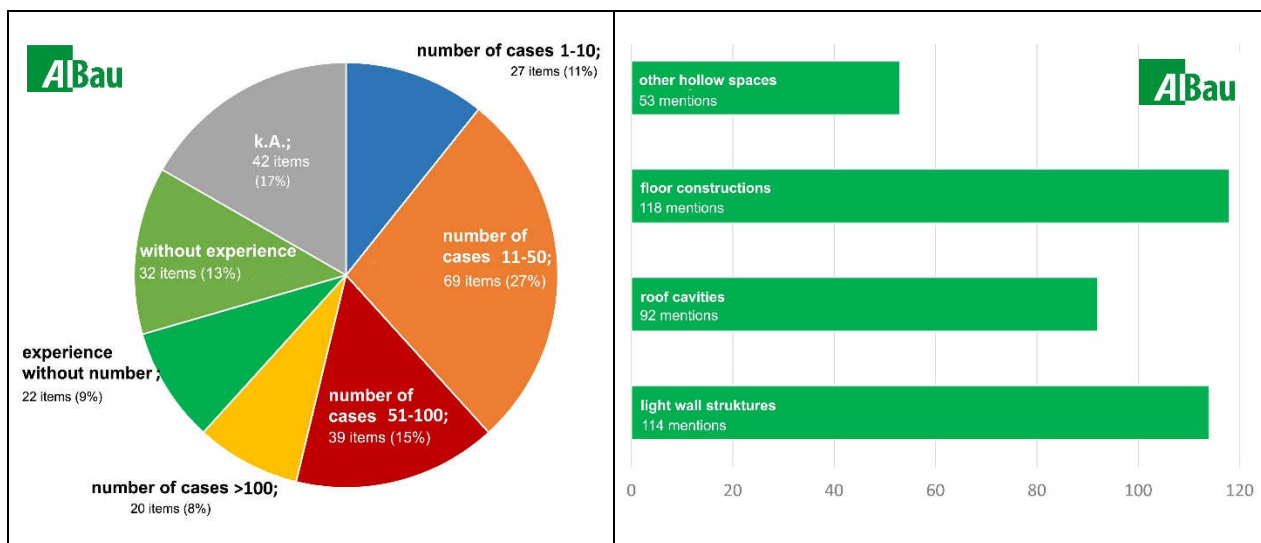
Fig. 1: Number of cases per participant

Fig. 2: Frequency of damage per area.

Of the 251 experts (roughly 11%) who participated in the survey, 177 (i.e. 70% of 251) had had to deal with mould damage. The number of specified cases shows the broad response to this problem area: About 15,000 cases of mould damage have been dealt with over the past ten years by the experts taking part in the survey. Each participant had inspected and evaluated from only one case, or more than 100, up to 2,000 cases (Fig. 1).

The results show that mould infestation was found to be most frequent in floor constructions (118 of 177 items) and in light wall structures (114 items), whereas it was less frequent in roof cavities and other hollow spaces, e.g. under showers, behind the cladding of façades or on installation levels (Fig.2).
